## PTOLEMAIS IN LIBYA.

EXCAVATIONS CONDUCTED BY THE MISSION OF THE INSTITUTE OF ARCHAEOLOGY,  
WARSAW UNIVERSITY IN 2004 AND 2005. REPORT ON TWO SEASONS OF EXCAVATIONS\*  
(PL. 81-110)

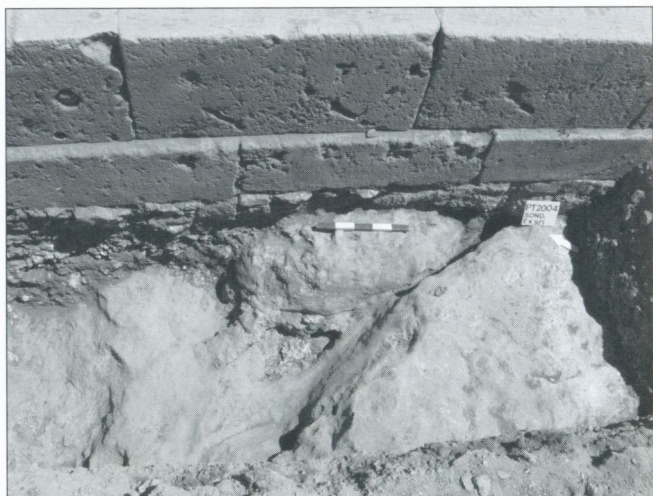
Fig. 1

Hellenistic foundations of the villa, placed directly on bedrock, were reached in all above-mentioned areas (**Fig. 1**). The external walls of the villa, built on Hellenistic foundations, were found in sondage EX9/1 (W wall of villa; **Fig. 2**) and in trench CXCI81 (E wall of villa; **Fig. 3**).

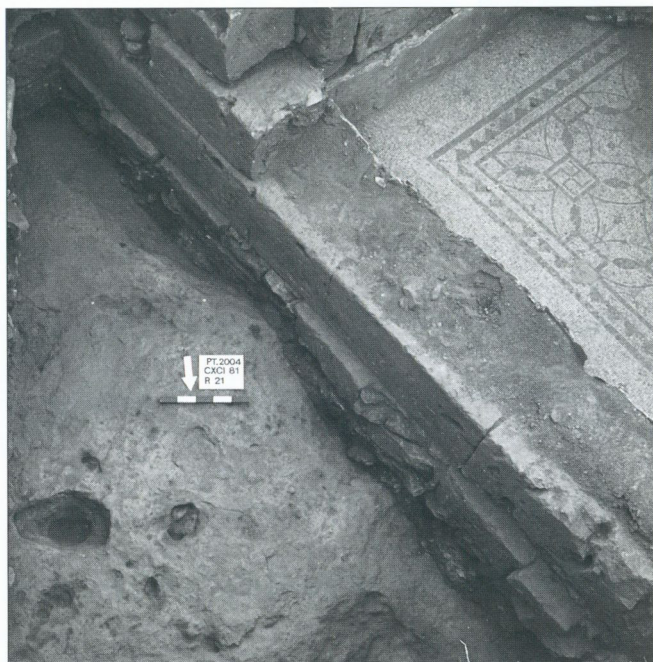
Fig. 3

Works in the trench were previously carried out in spring 2002. During this season's campaign, excavation works in CXCI81 trench were undertaken in order to determine whether the main rooms of the villa were planned symmetrically around the central peristyle. W47 and perpendicular to it W45 and W49 date to the Hellenistic period. W47, situated directly on bedrock, forms the exterior wall of the villa (**Fig. 3**).

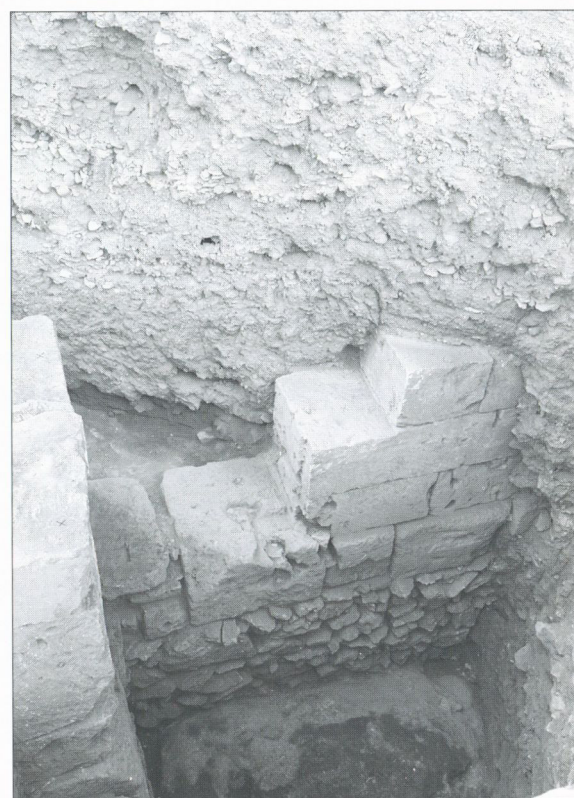
Fig. 5

**Room 26.** Only the S-W corner of the room was excavated (**Fig. 5**). The upper layer of R26 was covered with stones from destroyed walls W24 and W42. The pottery finds as well as two stone decorative elements: a volute of a Byzantine capital and fragment of a bas-relief with floral decoration date clearly to the Byzantine period.

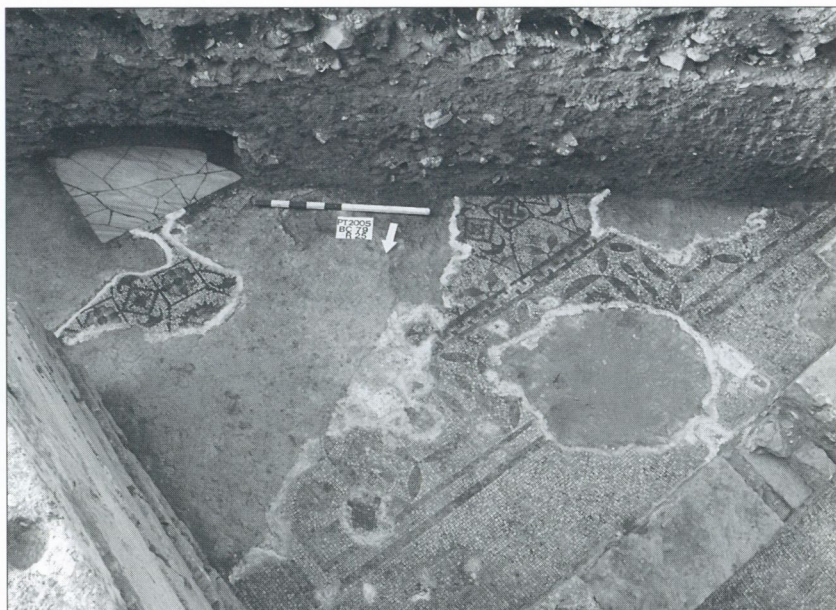
Fig. 6

**Room 25.** The area was previously explored in 2002. During this season's works in S profile of BC79 (S of W46) a mosaic pavement was partially uncovered (M10; **Fig. 6**).

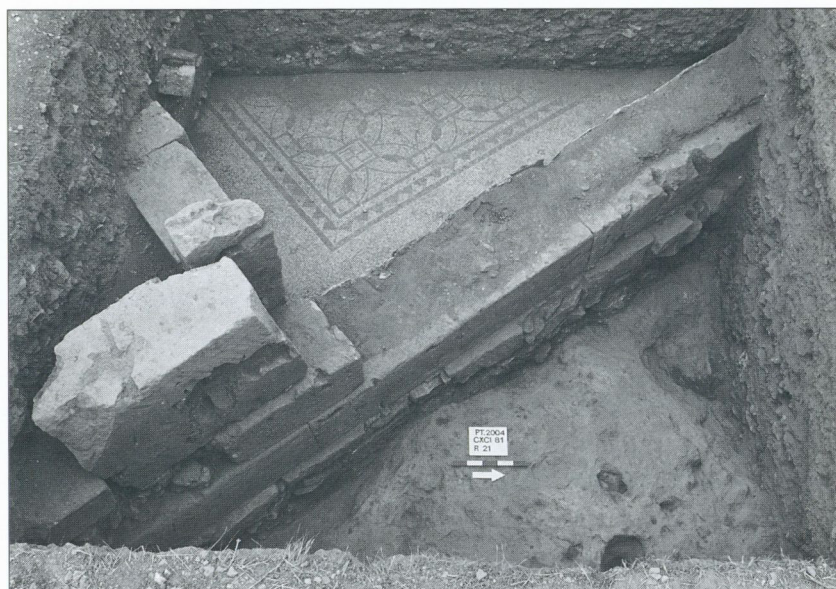
Fig. 7

On these Hellenistic foundations (W47 in its S part and W45) Byzantine constructions were built up (**Fig. 7**; W48 above S part of W47; the Byzantine wall above W45 does not have a separate number). W45 in its upper level is a continuation of W10 and forms N corner of the Byzantine blockhouse.

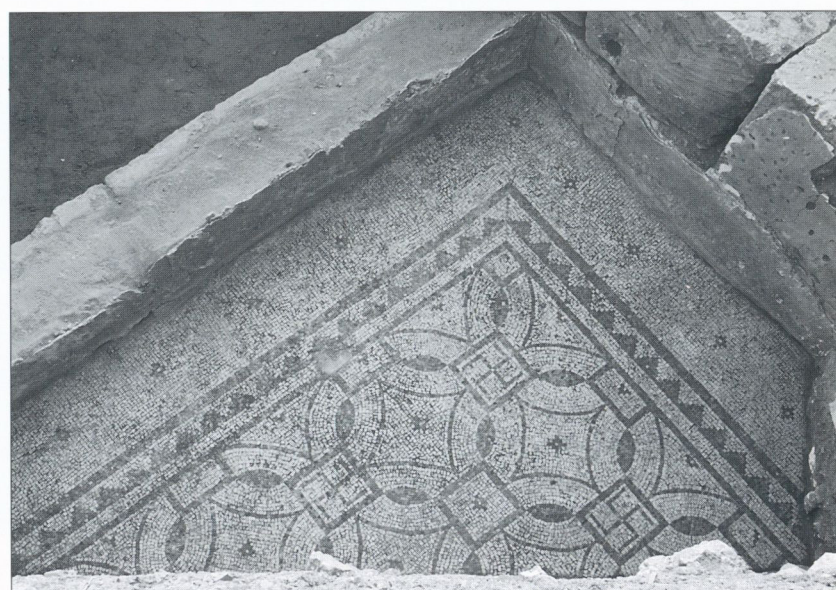
Fig. 8

The following mosaics are uncovered: in rooms R7 and R11 mosaic M1 (Fig 77, 78); in room R14 mosaic M6 (Fig. 8, 9); in west part of peristyle mosaic M4 (Fig. 79); in room R25 mosaic M10 (Fig. 80). All of them are made in *opus tessellatum* technique and are decorated with geometrical ornaments. Some areas of mosaics are seriously destroyed: smaller and greater lacunas in tesseras layer, weak and degraded mortar support, deformed and dirty surface of mosaics, loosing tesseras.

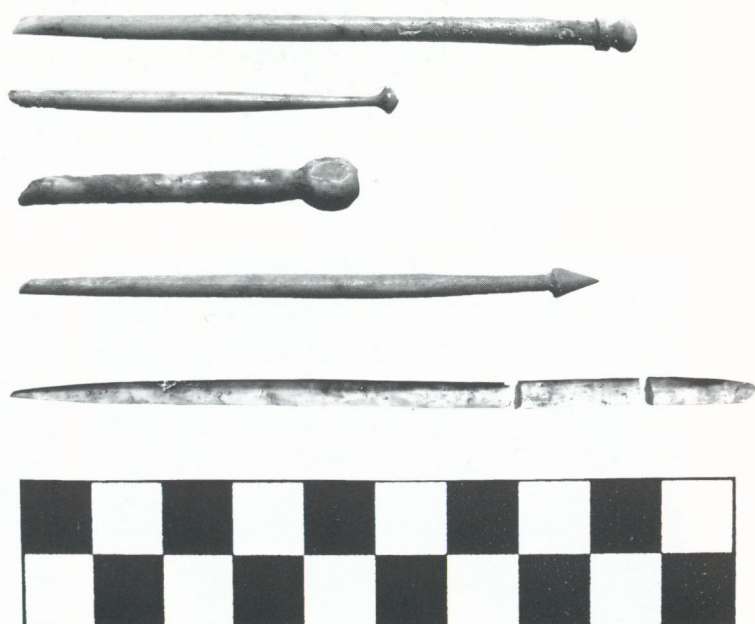
Fig. 28

It seems necessary to note that in addition to the coarse pottery found in the entire area described above (R10, R11, R22, R18, R24 and W of these rooms), more than 20 bone pins of differentes shapes and dimentions were also obtained (**Fig. 28**).

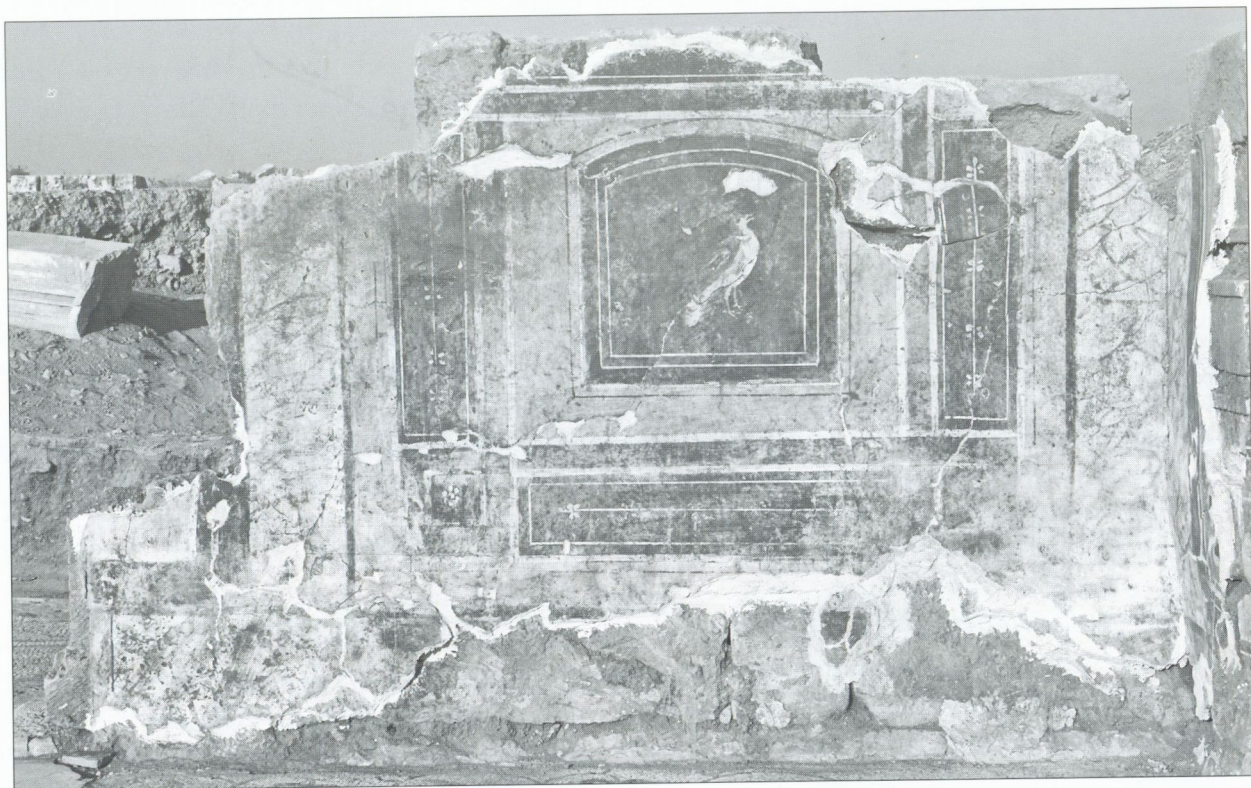
Fig. 31

After final excavation of baulks 1 and 3 large fragments of painted decoration on the walls W2 (approx. dimensions: max. width 229 cm; max. height 105 cm) and wall W3 (approx. dimensions: max. width 224 cm; max. height 143 cm) were uncovered (Fig. 31, 75). The paintings are preserved in the corner between two mentioned walls in the room with Dionysus mosaic. On the walls another fragments of geometrical decoration are visible – red, green and yellow squares and rectangles, painted columns with imitation of marble, white lines and simple floral ornaments. Moreover, on the wall W3 the bird on the green background is presented. The paintings were seriously destroyed. The plaster layers in many places were detached from the stone support. There were many empty spaces

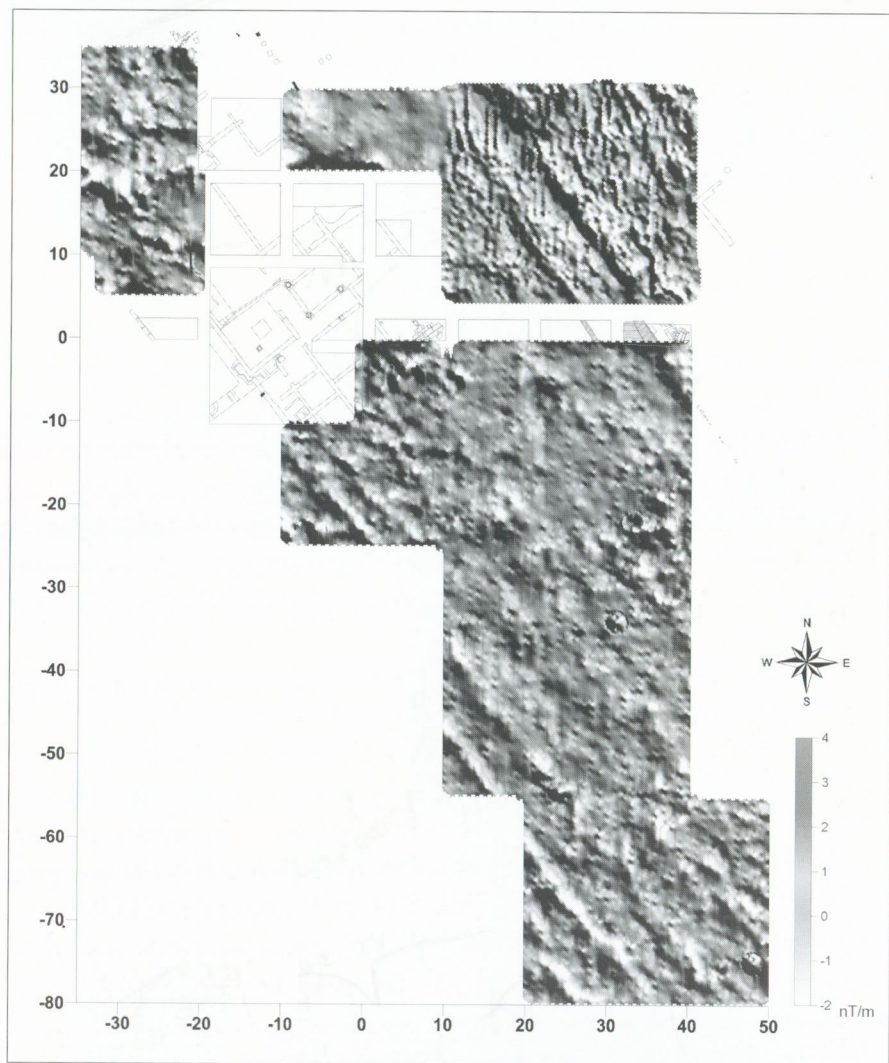
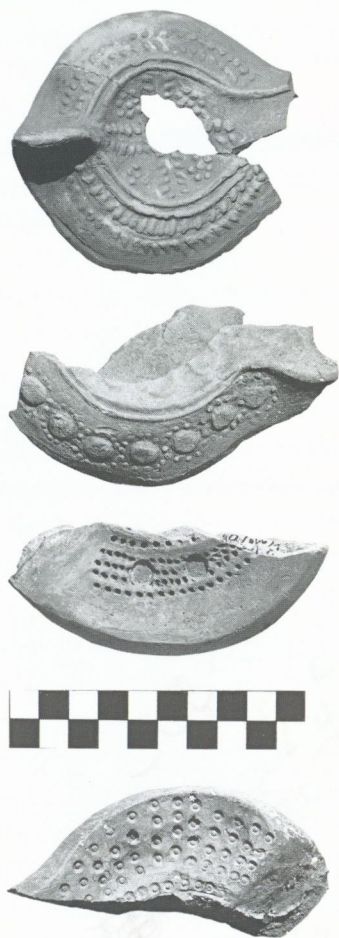
Fig. 35

a construction dating to the end of the 4th cent. A.D., built on earlier Mid-Roman walls, was found (**Fig. 34**). This construction functioned probably as a workshop for the production of lamps (**Fig. 35**). Even though oil lamps were very abundant in Ptolemais, their local production was not previously confirmed.

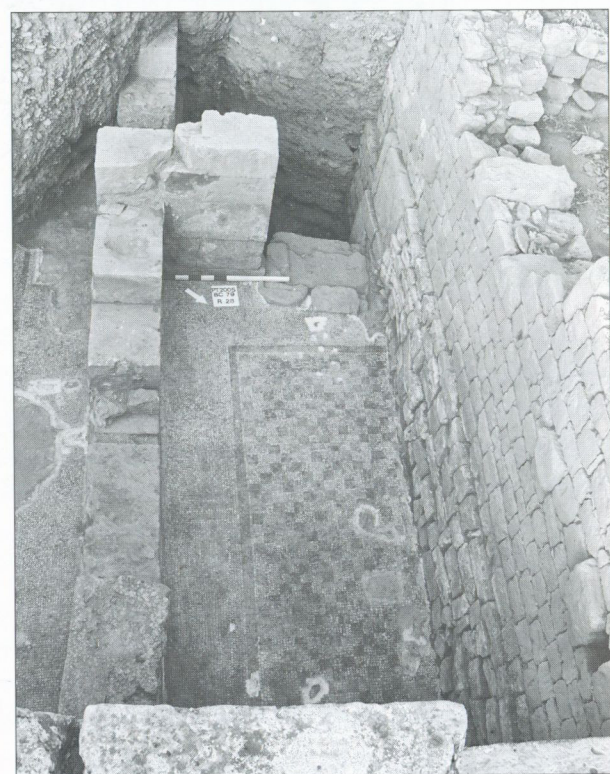
Fig. 40

**Room 28.** The room is delimited by walls W24, W27, W29 and W62. Apart from W24, the other walls were raised on earlier constructions (**Fig. 40**). Wall W24 was built in Late Antiquity on a geometric mosaic M11 (**Fig. 41**), decorated similarly to mosaics in R4, R8, R11. The remains of wall W66 (contemporary with M11, W62 and W29), with small fragments of paintings preserved (**Fig. 42**) – were used as foundations for wall W27.

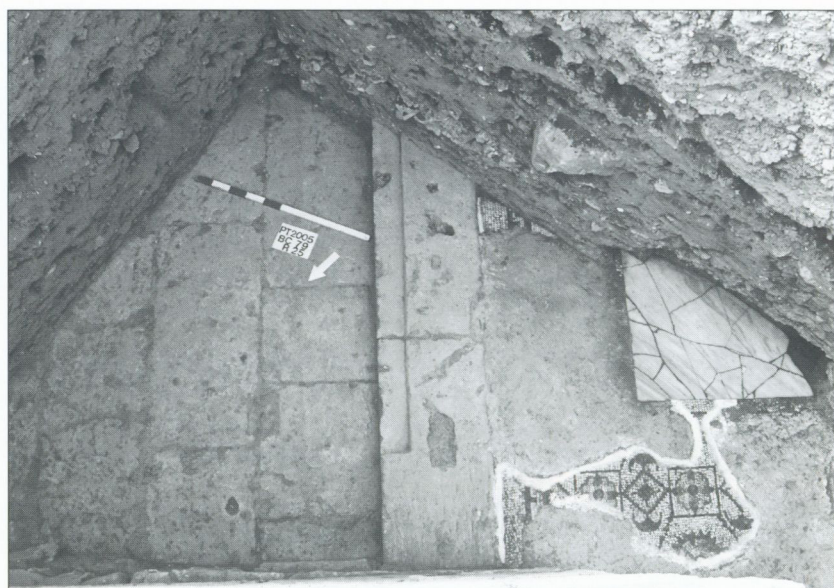
Fig. 43

**Room 29.** The room is covered with a stone pavement (**Fig. 38**), analogous to the pavement found SE of W75 (trench CXCI91). The room is connected to room R25 by a wide doorway (part of W66; **Fig. 43**) and can be interpreted as a paved courtyard. The foundation of wall W22, perpendicular to W27, was placed on the pavement in R29.

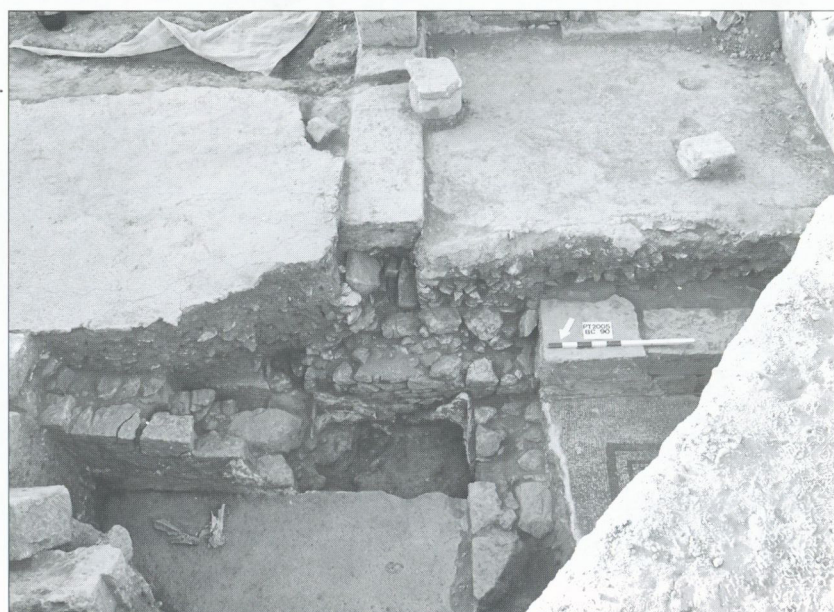
Fig. 45

The analysis of the correlation between walls W5, W38, W63, W68 (**Fig. 45**) has brought interesting information. The late antique wall W38 was moved ca 0.5 m S in relation to Hellenistic W63 (a coin of Cyrene dated to the 3rd cent. A.C. was found in the wall). Similarly, W68 was displaced by ca 0.5 m W from W5. The displacement of the walls was used in Late Antiquity to construct a basin in S corner of R15 (**Fig. 46**), analogous to basins found in R18, EX10. The described structure is evidence of many phases of construction from the Hellenistic period to Late Antiquity and requires further analysis.

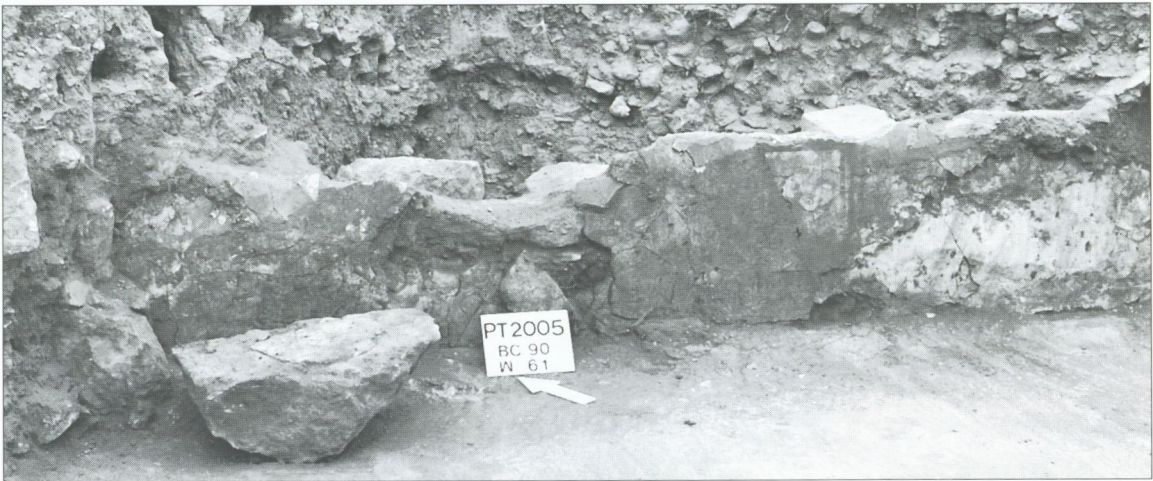
Fig. 47

R6: paintings on wall W5 were uncovered and treated (**Fig. 47**).

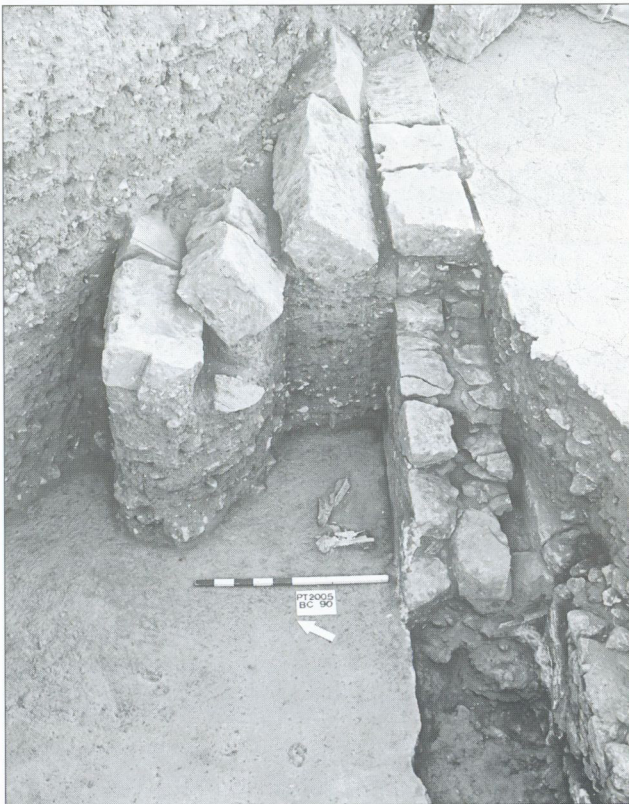
Fig. 48

**Room 15.** In consequence of an earthquake wall W63, dividing R13 and R15, collapsed and fell into R15 (Fig. 48). Three rows of stone blocks (36/05) were uncovered, placed on a destruction layer – fill of R15. A skeleton of a large domestic animal (Fig. 49) was found near wall W63, next to the basin.

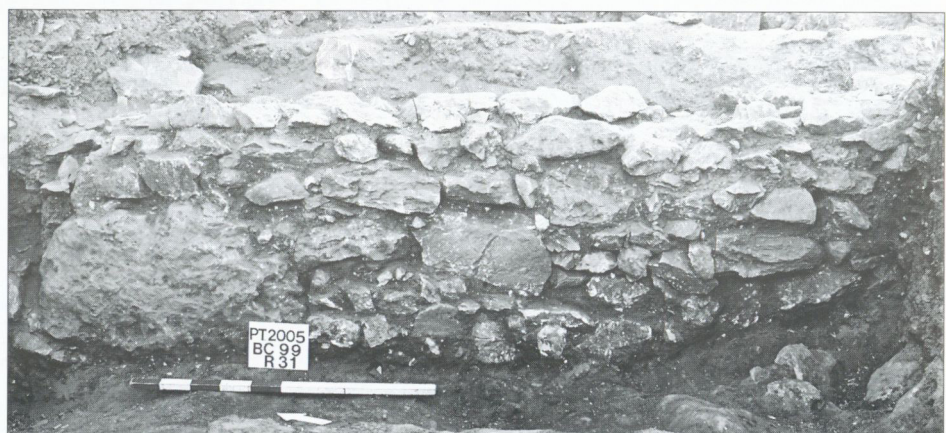
Fig. 53

This season excavation works were conducted in N part of the trench. The area of room R31, which is located SW of wall W70, W of foundations of wall W69 (continuation of wall W3) and NW from the negative of the wall W40 (the W part of this area was excavated in 2004 – sondage BC99/1) – was explored (Fig. 53).

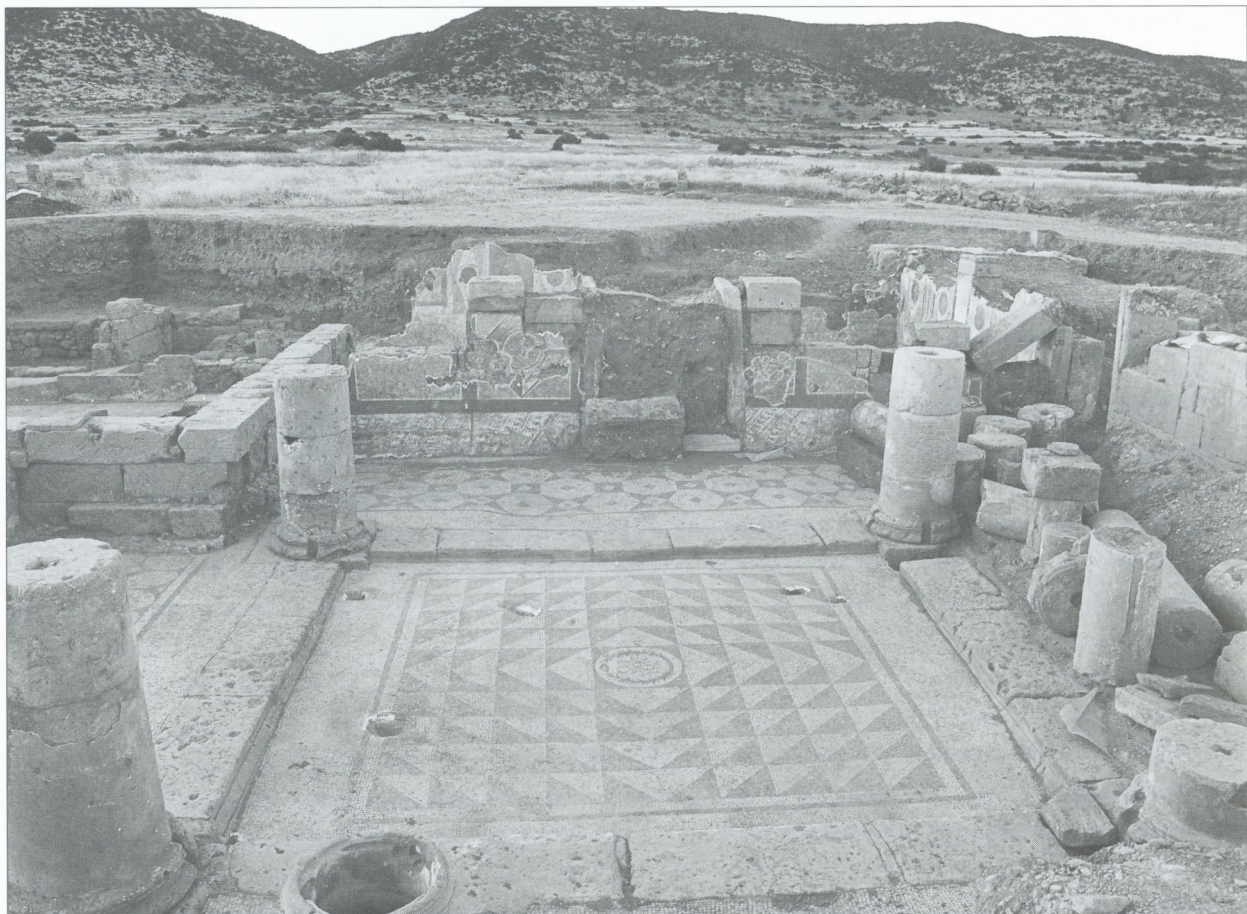
Fig. 55

This season the following mosaics were uncovered: M7 (**Fig. 82, 84**), M5 (**Fig. 55, 64**), M4 (**Fig. 63, 64, 85**), M6 (**Fig. 68, 86**), M10 (**Fig. 37, 39, 43, 44, 52** partly), M11 (**Fig. 40, 41**).

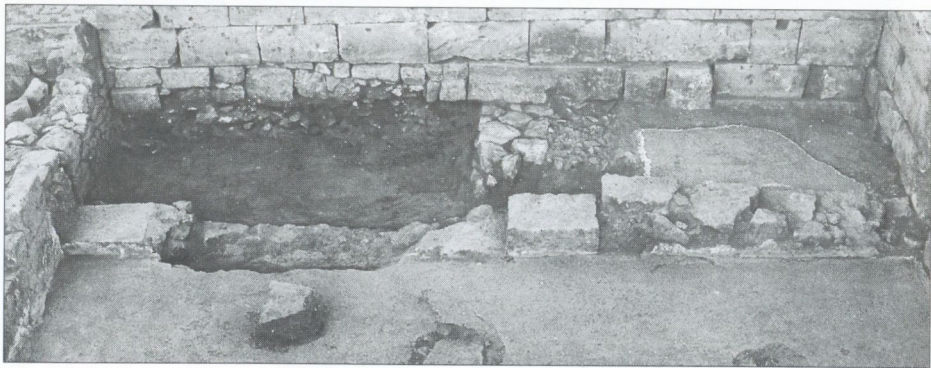
Fig. 62

**Room 33.** The room is situated in the NW part of the Late Roman structure and has a rectangular shape. In its N part, the E corner of the peristyle mosaic M4 is visible (**Fig. 62**). This area was separated from the rest of the room by foundations of wall W8 (133/05), which formed at an earlier phase, together with wall W5, the SE corner of the peristyle. Both E wall of the room (preserved on a level slightly higher than the pavement in R5) and the W wall belonged to the Mid-Roman phase of the villa and could have functioned as part of construction of stairs leading to the first floor of the building or as a corridor (**Fig. 63**).

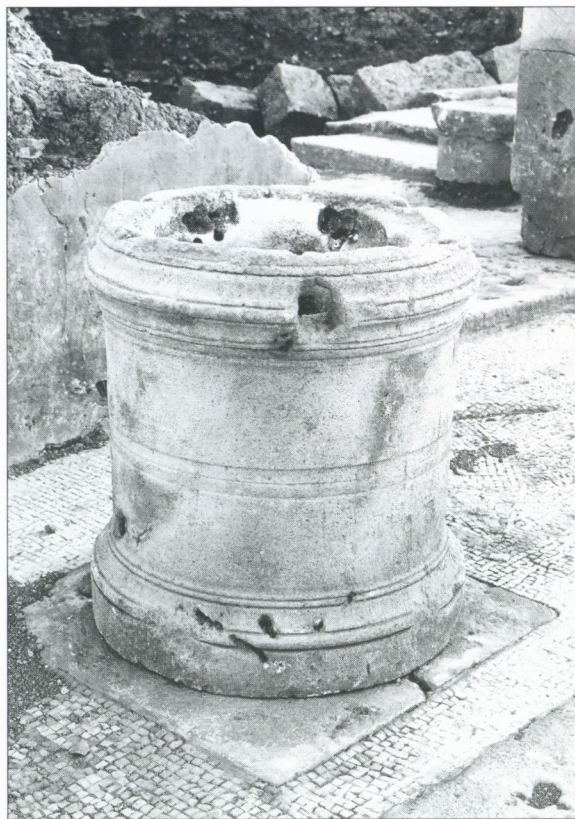
Fig. 65

The entrance to the cistern was decorated with a stone puteal (**Fig. 65**; 119/05). In the fill of the cistern, 4 coins were found (3 sestertii from the 3rd cent. A.D. and 1 Ptolemaic bronze) and a group of vessels (a dozen almost complete vessels) dated to the Mid-Roman period. The finds from the cistern seem to indicate that the peristyle was destroyed by the earthquake of 262 A.D.

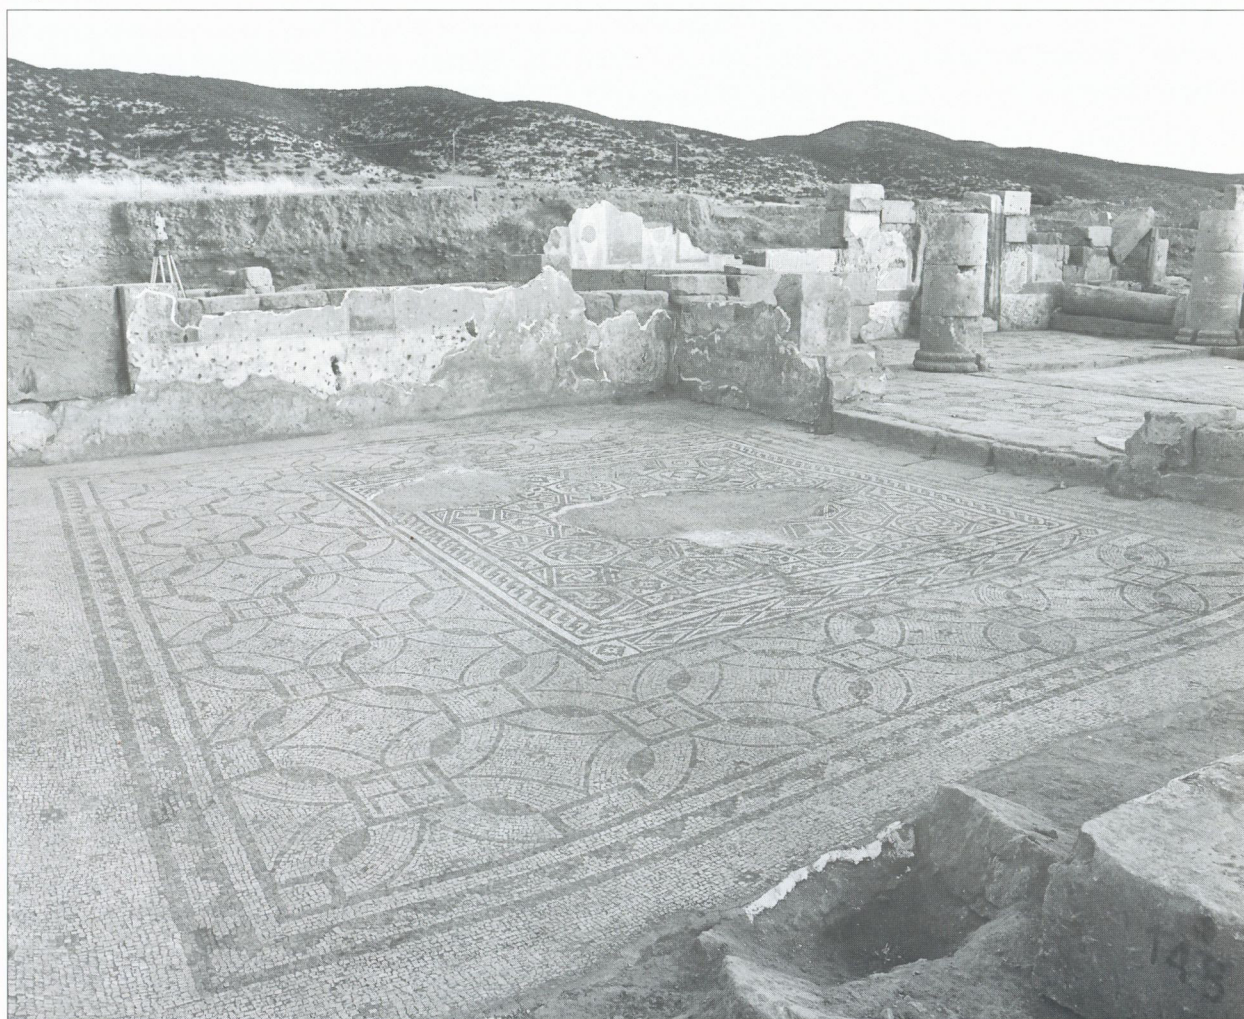
Fig. 68

Works on baulk 8 concentrated in its central and S part. Room R14 with mosaic M6 was uncovered and documented (**Fig. 68**).

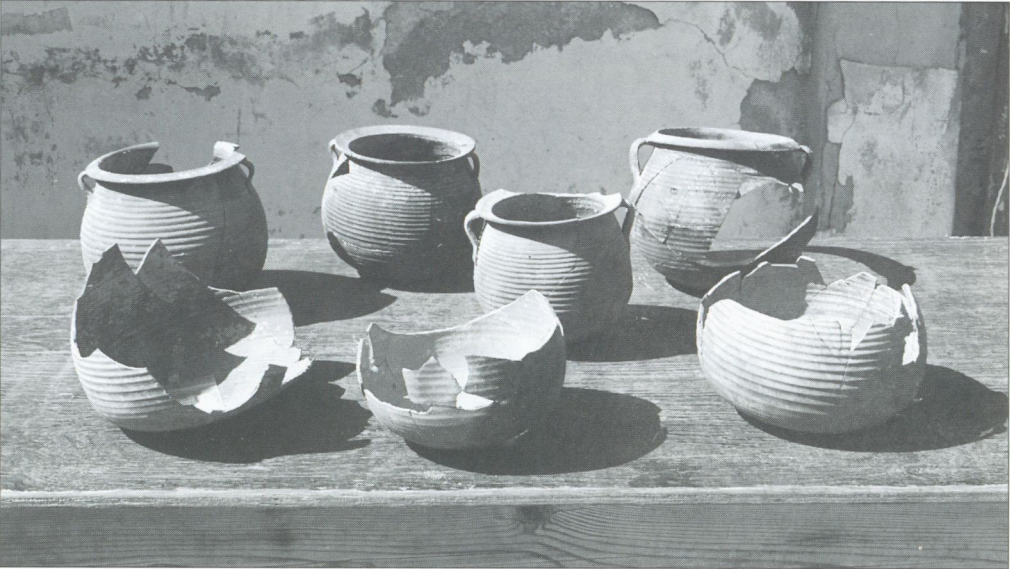
Fig. 69

The most interesting and most numerous pottery finds excavated during the 2004 season, represent categories of Mid-Roman coarse pottery produced in local workshops (Ptolemais?). Hundreds of fragments and several whole vessels of local Mid-Roman coarse pottery were found (Fig. 69). Noteworthy are numerous fragments of Mid-Roman pottery and nearly 20 almost complete vessels found in an important deposit – fill of the cistern in the peristyle. All these vessels, representing mainly 2 types of local Mid-Roman jugs, indicate that the destruction of the villa was caused by the earthquake of the year 262 A.D. This hypothesis is confirmed by coins found in the same archaeological context (2 Antoninian sesterii and 1 post-Severan sesterius).

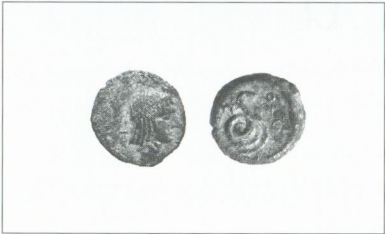
Fig. 70. Skala 1:1

A number of phenomena, typical for numismatic finds from Cyrenaica, were observed. Cyrenaican ases struck by Roman officials: Lollius, Pupius Rufus and Palikanus belong to a group of coins struck and halved during reign of Augustus. The 2005 season brought an extraordinary numismatic find (**Fig. 70**). It is a small *quadrans* struck in Ptolemais, representing head of Libya (typical Ptolemaic motive) with letters: ΠΙΤ (short form for Ptolemais in Greek) on obverse and serpent on reverse with name of the Roman official A. Pupius Rufus: ΠΙΟΥΠΙΟΙΟC. This type of coin is preserved in several examples but all of them have Λ (Libya) instead of ΠΙΤ (Ptolemais). This unique coin seems to testify to the existence of a mint in Ptolemais established after 37 A.C. by P. Canidius Crassus and functioning in the Pre-Actian period<sup>19</sup>. Several other coins found in the 2004–2005 seasons, very common for the region of Cyrenaica, represent coins previously attributed to Caesarea in Cappadocia. Characteristic for this group, struck during the reign of Trajan, Hadrian and M. Aurelius, is the pattern: head of Emperor on obverse, head of Zeus-Ammon on reverse. One coin of this group (cn/037/05) is worth mentioning: this is the silver hemidrachm, very rare and beautiful (**Fig. 71**). It is necessary to note that among the numismatic finds obtained during the Polish excavations in Ptolemais, the majority of large, bronze denominations from the Early Roman reign in Cyrenaica were halved. The production of smaller units (in this case semises, less frequently quadranses) obtained by cutting of coins (ases) in halves or quarters, is a well-known phenomenon, especially for the Western part of the Empire. This procedure served to complement the lack of small change on the local market. The group of halved coins from Ptolemais is the most numerous among the known examples from other archaeological sites in Cyrenaica.

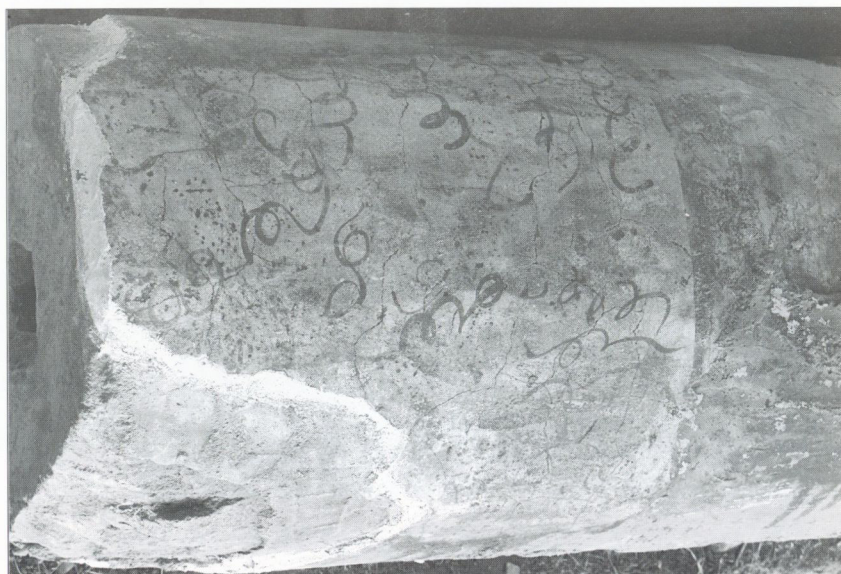
Fig. 76

There are found two columns and half-columns with painted decoration on the thin plaster. There are decorated with floral ornament – red floral scroll with leaves and fruits (Fig. 76). Weak edges of plaster were reinforced with mortar bands (acryl stucco mortar with sand 1:2). Paint layer was cleaned with water (sponges and paintbrushes), disinfected (3% Preventol in water) and impregnated (Paraloid B72 in acetone).

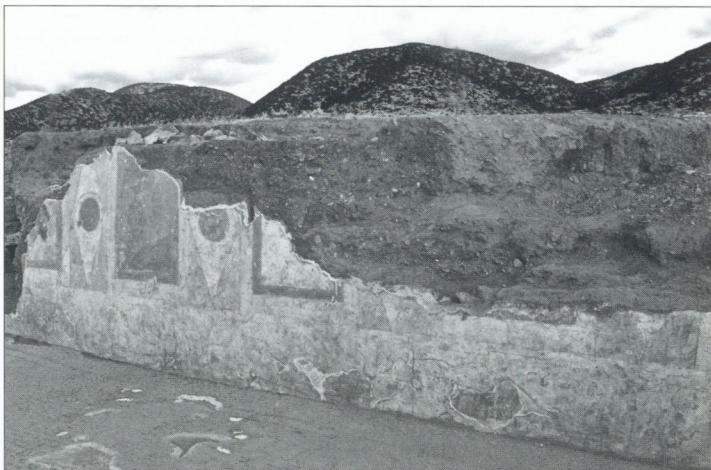
Fig. 81

Room R1: During this campaign, the paintings on wall W14 were uncovered (Fig. 81); the remaining paintings on walls W3 and W8 were uncovered in 2002.

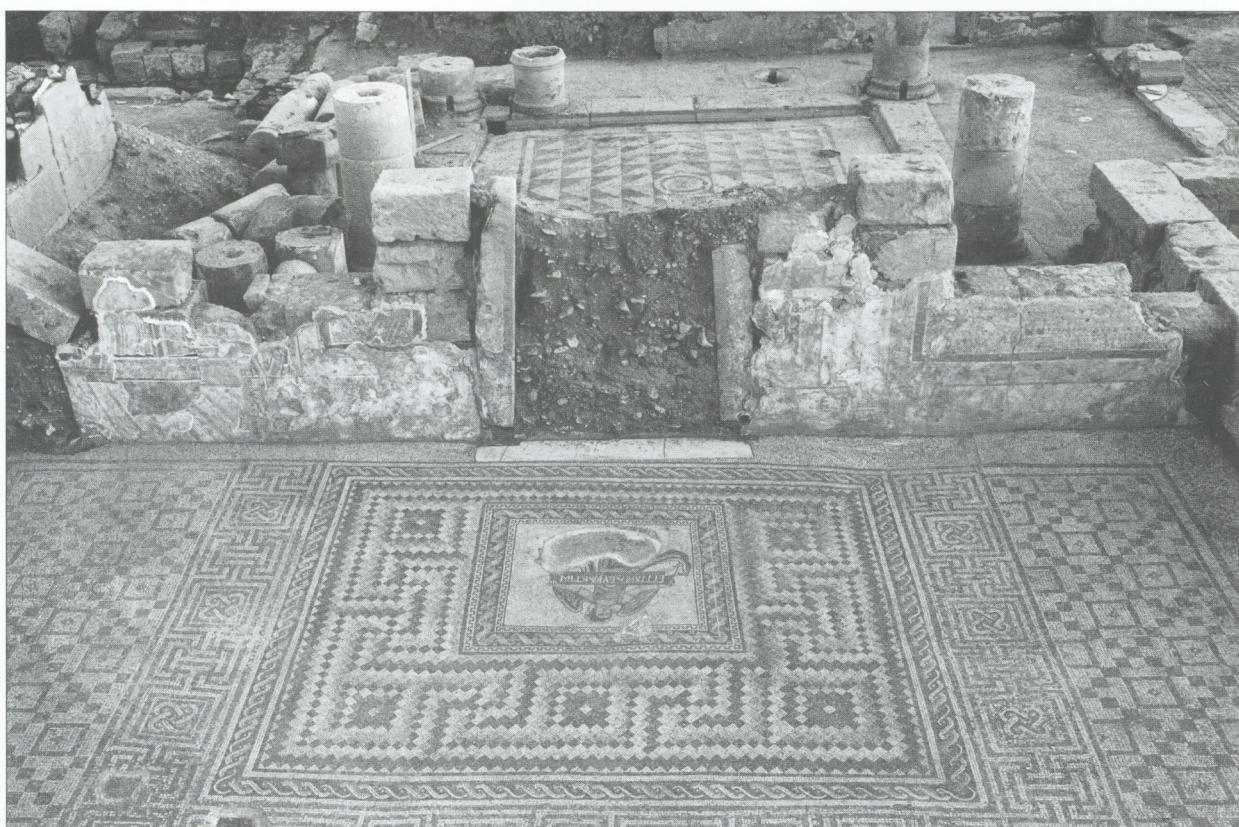
Fig. 82

R19: paintings on wall W8 were uncovered and treated (**Fig. 82**).

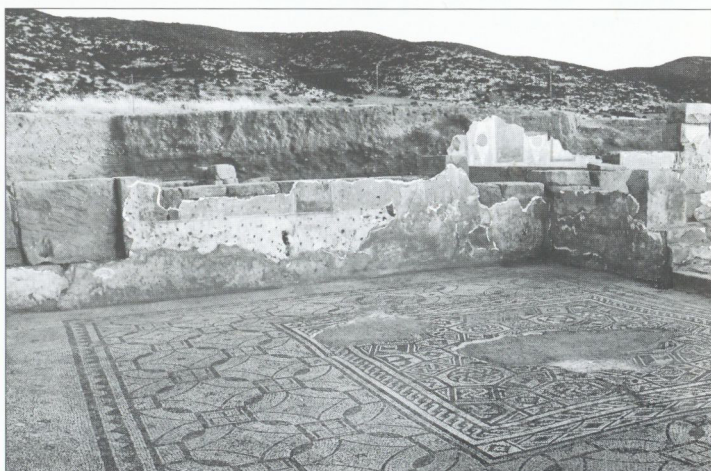
Fig. 83

R14: paintings on walls W45 and W5 were uncovered and treated (**Fig. 83**).

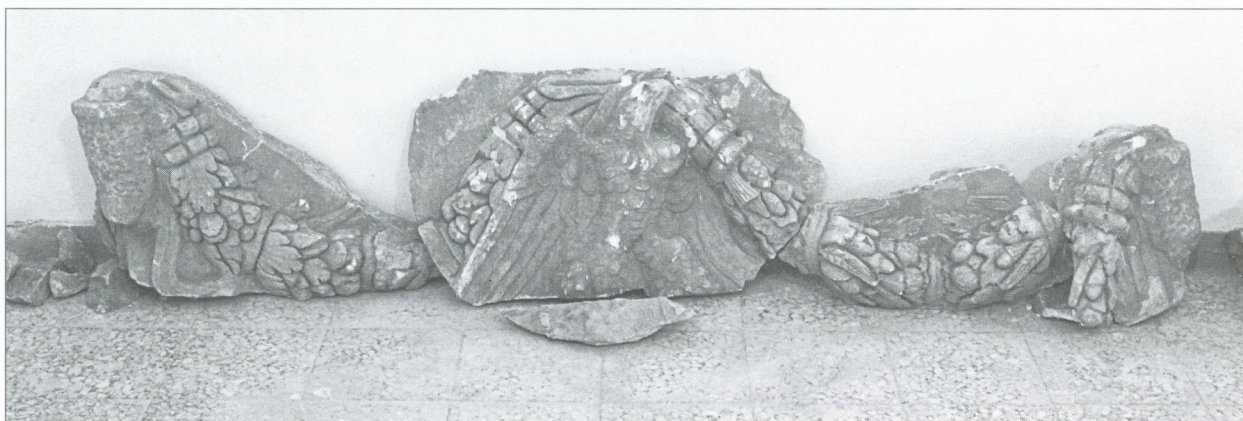
Fig. 87

In 2003 several, large fragments of a sarcophagus case and a fragment of the lid were brought to the local museum in Tolmeita (**Fig. 87**). In October 2004, another part of the same sarcophagus (the bottom part of the case) was found in the East Wadi of Tolmeita, called Wadi Umran (**Fig. 88**). The fragments were identified as part of one object and a decision was made to reconstruct the fragmented pieces by a Polish conservators.

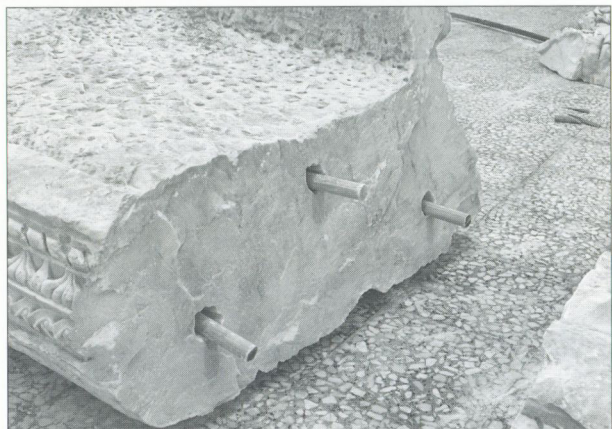
Fig. 90

The fragmentary pieces of the sarcophagus were classified, documented and photographed. First, the layer of soil covering the relief was removed with the use of brushes (natural and synthetic brushes). Attempts were then made to restore the white color of the marble by means of compress of 10% and 20% ammonium hydrocarbonate (NH<sub>4</sub>)HCO<sub>3</sub>. The chemical substance used did not allow for the removal of the reddish-brown color. It was therefore decided to remove the dirt with water, using soft brushes. The remaining bits of soil were removed with the help of a scalpel. Next, the two parts of the bottom of the case were glued together with epoxy resin Epidian 5 with hardener Z-1. This step was preceded by the drilling of three holes (2.5 cm in diameter) in both fragments, allowing for the placement of glass fiber rods (**Fig. 89**). The space between the rods and the holes was filled with putty and sieved sea sand (1:1). The two glued fragments were then tied with a rope. Next, the walls of the case were pieced together and strengthened before gluing by glass fiber rods. Smaller fragments were glued with epoxy resin (**Fig. 90**).

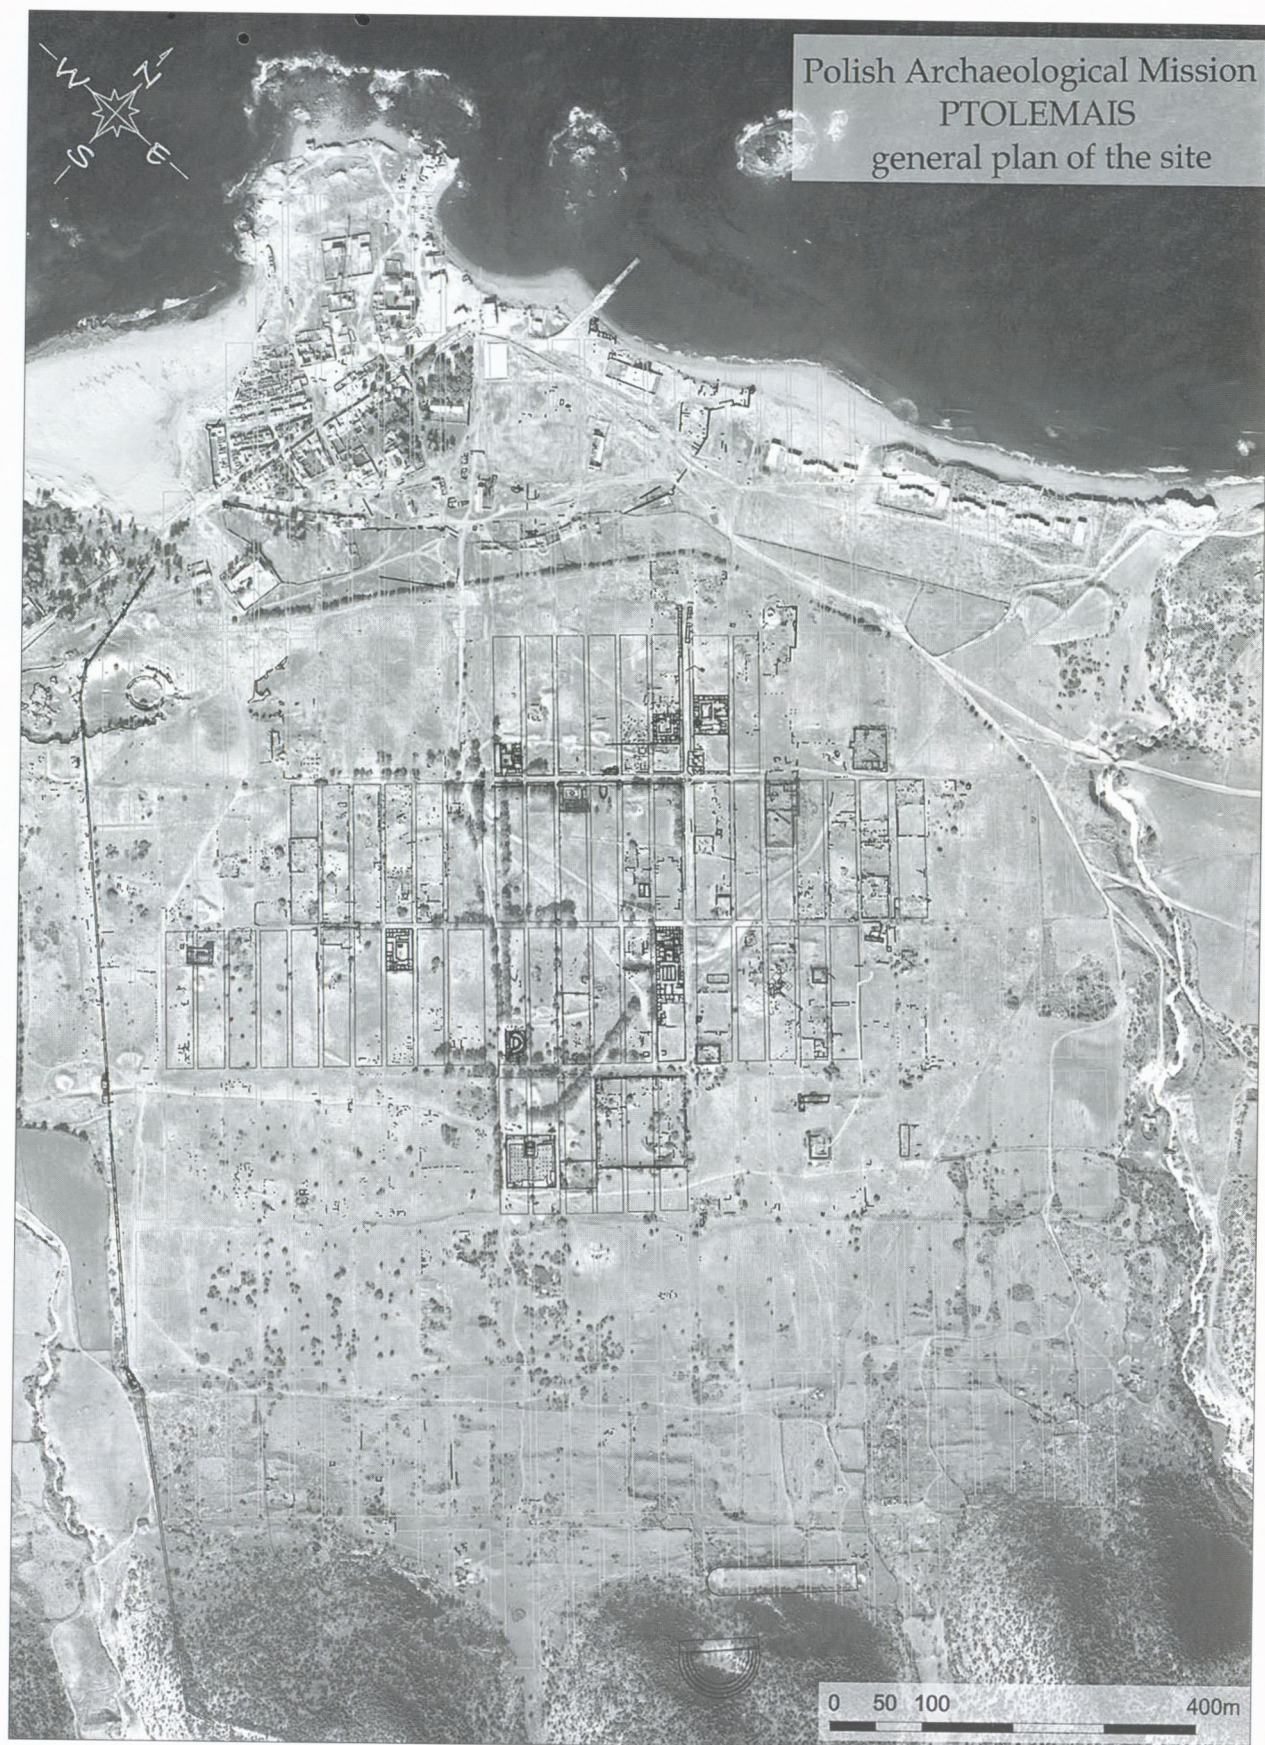
Fig. 91

The satellite photo was connected to the existing city plan and calibrated with GPS control points and with certain points on the plan of the city. As result, the satellite photo was transformed into a photographic map of the city (**Fig. 91**). This procedure allowed us to point out: architectural structures, open areas, insulas (as well as layout of main streets) and city limits.
