Title: **The “Square Feature” in the harbor: Excavations in Berenike 2010–2011**

Journal: *Polish Archaeology in the Mediterranean* 23/1 (Research 2011)

**Keywords:** Berenike, Red Sea, harbor bay, temenos, early Roman, gypsum anhydrite/coral heads architecture, inscription

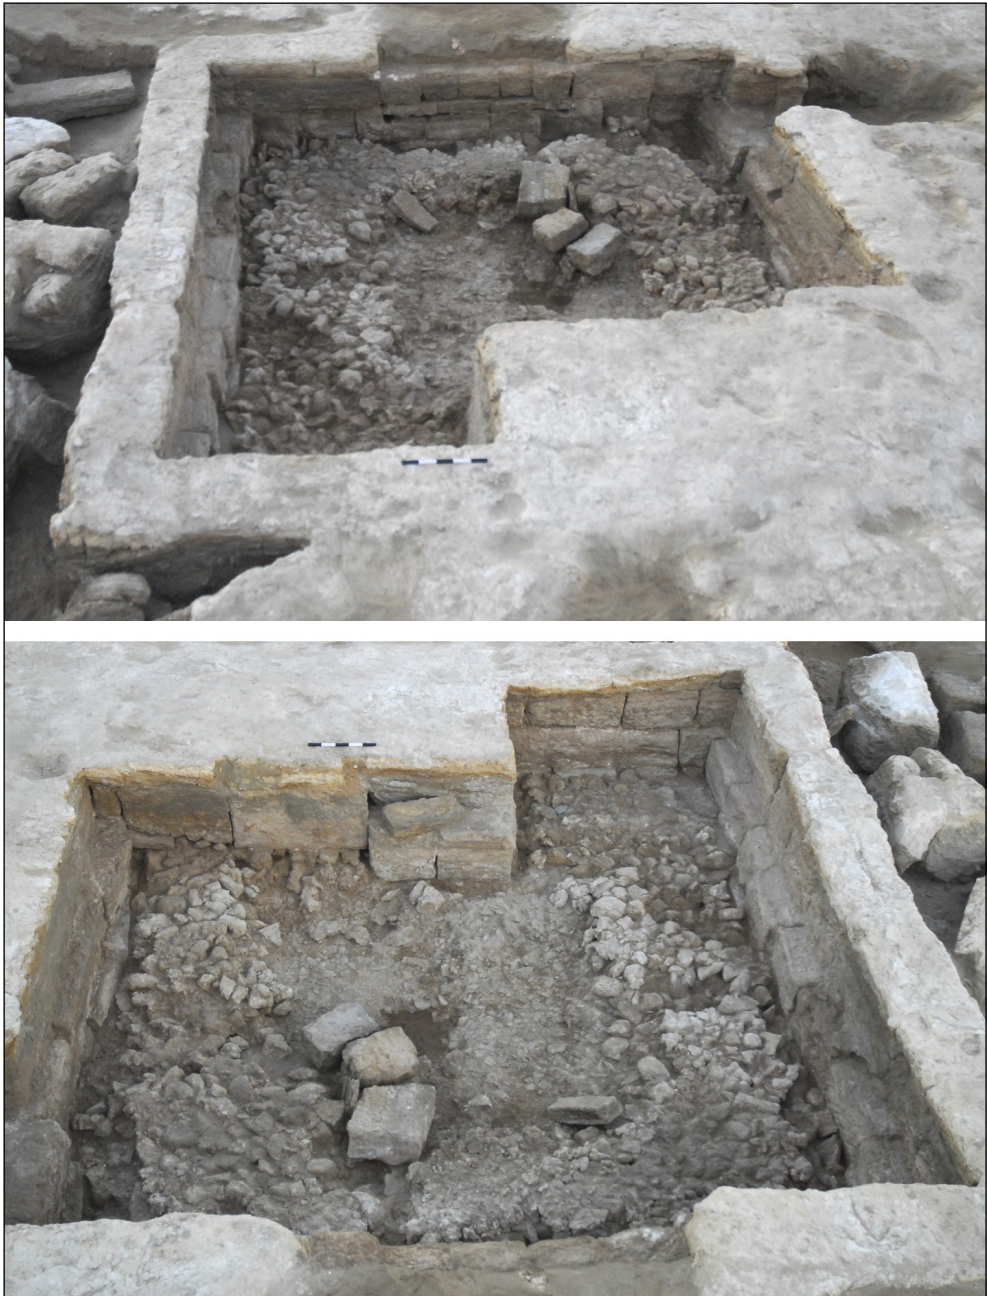
*Fig. 3. "Square Feature" after excavation: top, view of north face of south wall (top of photo); bottom, view of south face of north wall (top of photo). Scale = 0.50 m (Photos S.E. Sidebotham)*

The walls were preserved at least three courses high [*Fig. 3*], but of these the blocks of the topmost one were either intentionally half the thickness or substantially eroded when the melted surface of gypsum anhydrite formed on the latest identified occupational ground surface. The overall impression is of a structure built of recycled ashlar that were roughly dressed, some bearing characteristic traces suggestive of quarry marks. The average height of the blocks in the two lower courses was 0.36–0.40 m,

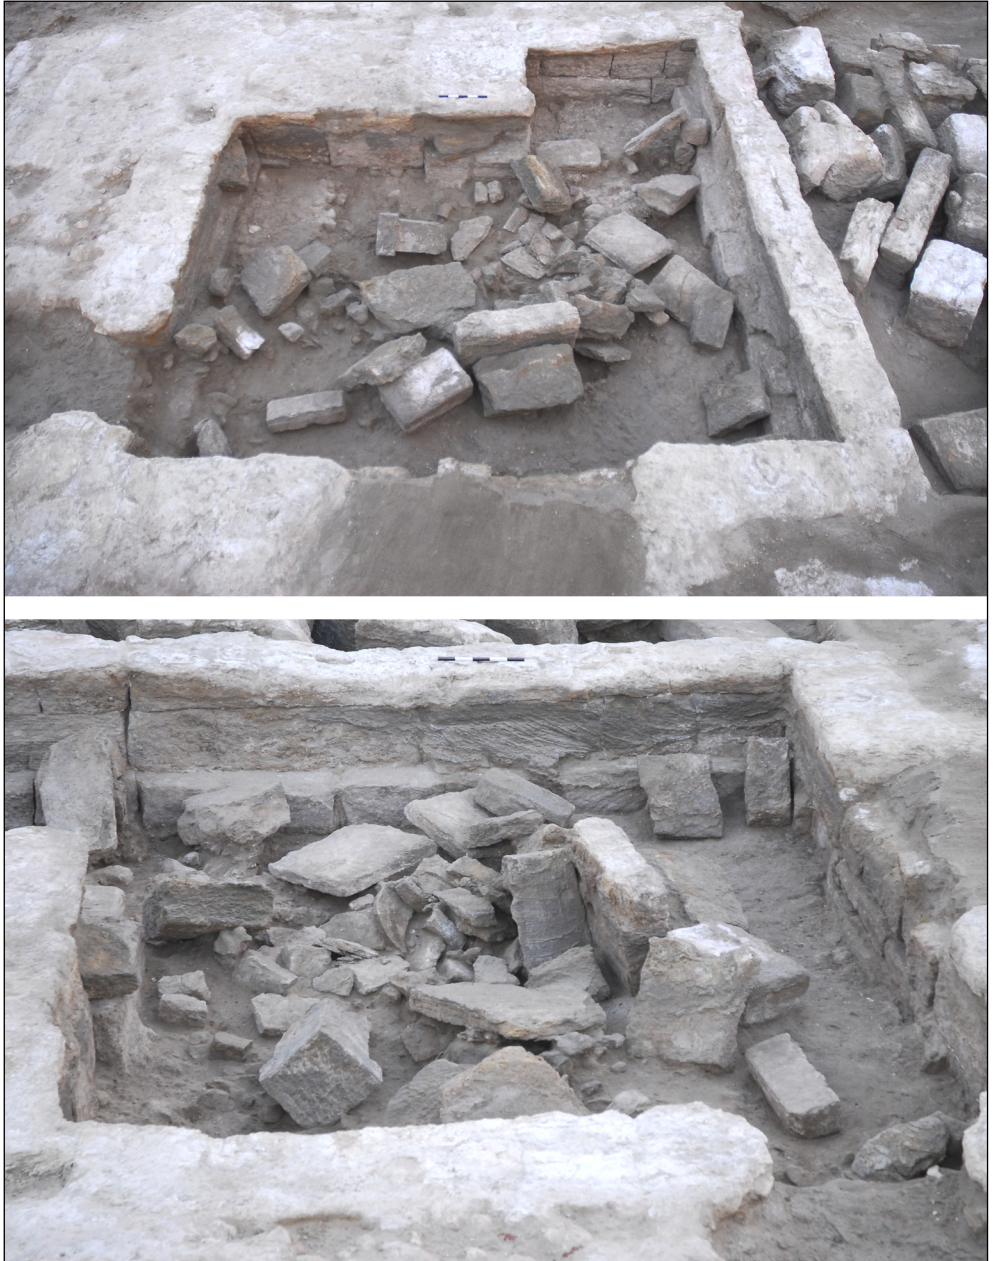
*Fig. 4. “Square Feature” with the tumble still in place: top, view from the south side toward the north; bottom, view from the west, note western doorway at bottom right. Arrows point to the inscribed stone (on left) and huge slab in the center (on right). Scale = 0.50 m (Photos S.E. Sidebotham)*

Architectural blocks as well as the inscribed altar stone lay tumbled inside the "Square Feature" [Fig. 4]. The tumble demonstrated evidence of having been toppled violently and some of the blocks appeared to be in an architectural order. Especially a group of large stones in the center, which look as if they had fallen from the south. The smaller, thinner and more fragile pieces of stone are found at the bottom of the tumble, basically inside the empty space between the coral heads and fanning out to the side walls in more or less one line. The big blocks appear on top. A huge flat slab (1.13 m by 0.65 m, 0.24 m thick) was found standing on the long side, as if it had slid off a bench or platform and ended up resting on its side. Upon closer analysis the blocks in the tumble can be separated into groups. For example, three blocks of smaller size are lined up against the coral heads in the southwestern corner of the empty center space in the floor of coral heads [see Fig. 3]. Two slabs were found resting against the "footing" in the southeastern corner. A group of blocks just next to the western doorway appear to have fallen from that direction; they could have been part of some kind of door-framing structure. The large blocks in the middle may have crushed some structure underneath and in the center space free of coral heads — perhaps a pool-like structure with slabs lining the sides. A considerable assemblage of about 30 red brick fragments found in the fill [Fig. 5, bottom right], mostly in

The inscribed stone lay clear of the main tumble, sideways, inscribed face down, base toward the west (for the inscription, see below) [see Fig. 4]. Its top, facing the east and center of the "Square Feature", was crushed. It may have been toppled from a central position inside the room, perhaps by the large blocks falling from the south, or it may have fallen from the podium or the apparent platform in the northwestern corner, but it is difficult to imagine how the forces working on the stone would have caused it to fall in this particular way.

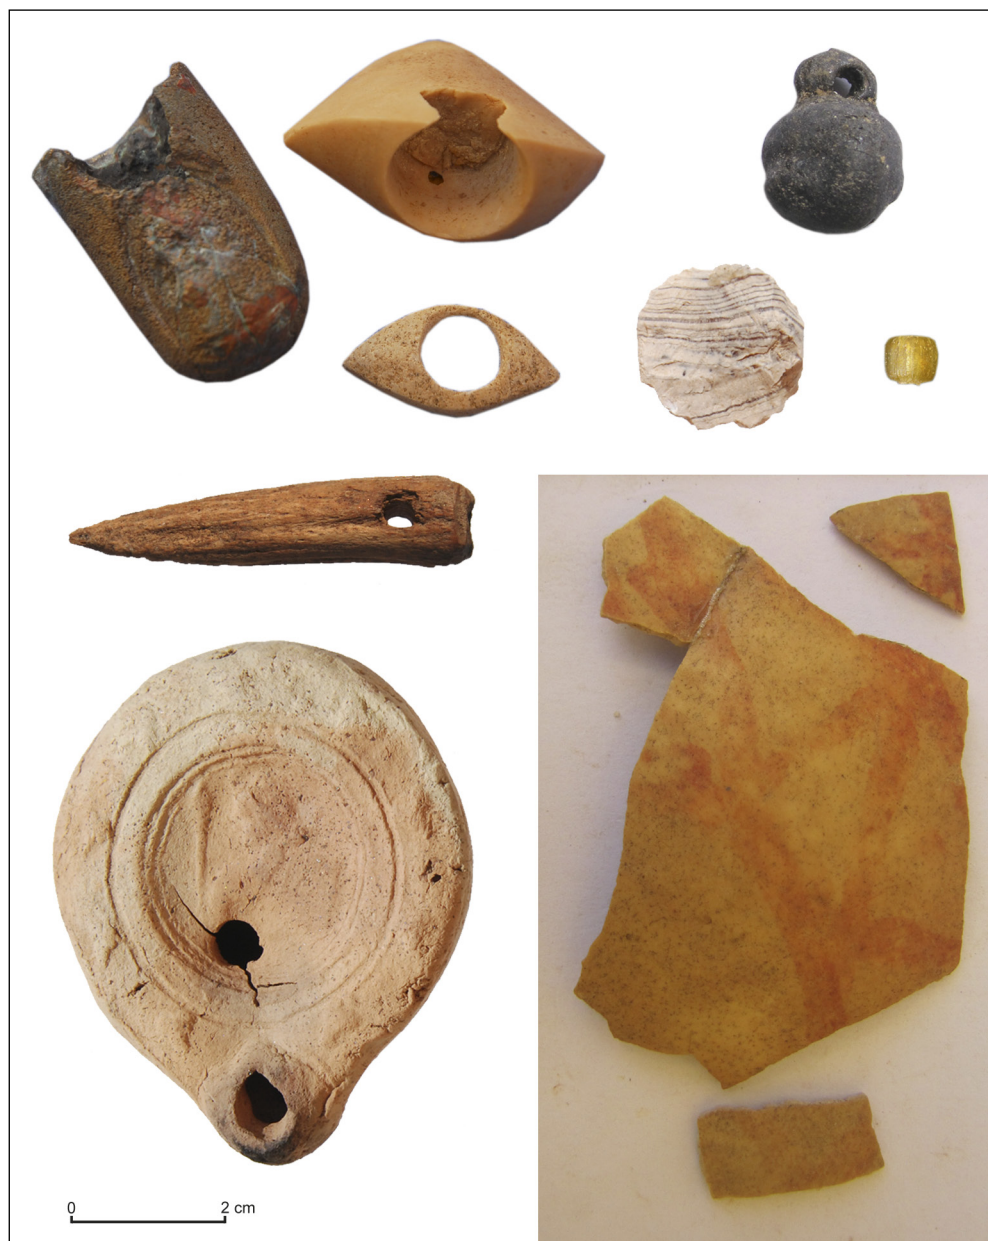
*Fig. 7. Artifacts from the fill of the "Square Feature": top, toe of a bronze statue of almost double lifesize proportions; eye inlays; glass pendant; banded agate cameo blank; gold-in-glass segmented bead; center left, bone needle; bottom left, lamp with Maenad bust on the discus; bottom right, ostrich eggshell fragment with red-painted decoration (Photos S.E. Sidebotham, B. Wójcik, I. Zych)*

a quantity of red brick fragments (which were also spread throughout the trench and beyond the door in the west wall), some ostrich eggshell fragments, a few bearing red-painted geometrical decoration and more importantly, a fragment of the toe of an almost double lifesize copper-alloy statue [Fig. 7]. Moreover, the fill here contained large quantities of goat bones and a few horns. Elsewhere in the sand fill two different eye inlays, both made of white stone, were recorded [Fig. 7]. The bigger one came surely from a bronze statue, the smaller one is typical of the kind of eye inlays used in animal mummies of the Pharaonic and Graeco-Roman periods. Otherwise, the fill contained a few glass beads, including a gold-in-glass example, a number of glass pendants, some burnt through, a banded agate cameo blank [Fig. 7], an array of decorative stones, including beryl and carnelian, fragments of iron and copper-alloy artifacts, two illegible coins, some unremarkable glasses, a large cowry shell of the kind recovered from the nearby shrine in trench BE10-61, as well as

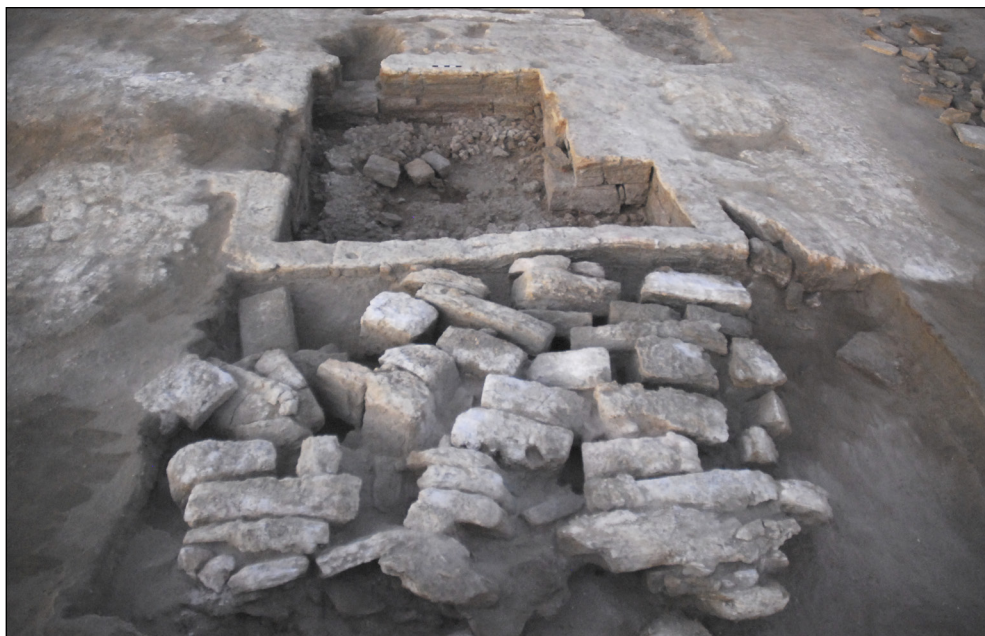
Fig. 8. Tumble of blocks to the east of the “Square Feature”, seen from the east. Scale = 0.50 m (Photo S.E. Sidebotham)

an underlying tumbled wall of ashlar of different size. This section of wall was uncovered over the course of the two seasons [Fig. 8]. The ashlar lay on a sloping bedding of sand falling from the back wall of the neighboring temple toward the “Square Feature”, in a semblance of order, perhaps even preserving a window or door slot, and definitely demonstrating the use of wooden clamps of the same, ‘swallow-tail’ kind as the ones attested in the walls of the early Roman Great Temple (of Serapis?) on site. The wall counted approximately nine courses of blocks, giving a total height of just under 5 m and extending just over 5 m in length. It remains to be ascertained from which side this wall fell and in which phase of the occupancy of the island temenos, but one thing is clear: the thickness of the ashlar

in the tumble, reaching 0.50 m, excludes the possibility of this collapsed wall being part of the “Square Feature” as it stands preserved today.
